SANTA CLARA RIVER ESTUARY HABITAT RESTORATION AND ENHANCEMENT FEASIBILITY STUDY

California Department of Fish and Wildlife
Fisheries Restoration Grant Program Agreement # P1350015
August 7, 2015

APPENDIX A – HYDRODYNAMIC MODEL DEVELOPMENT TECHNICAL MEMORANDUM

Date:	7/27/2015
To:	Jason Weiner, M.E.M., Wishtoyo Foundation's Ventura Coastkeeper Program
From:	cbec eco engineering - Chris Hammersmark, Dale Meck, John Stofleth, Denise Tu
Project:	Santa Clara River Estuary Habitat Restoration and Enhancement Feasibility Study - Project # 14-1023
Subject:	Hydrodynamic, Sediment Transport and Circulation Model Development

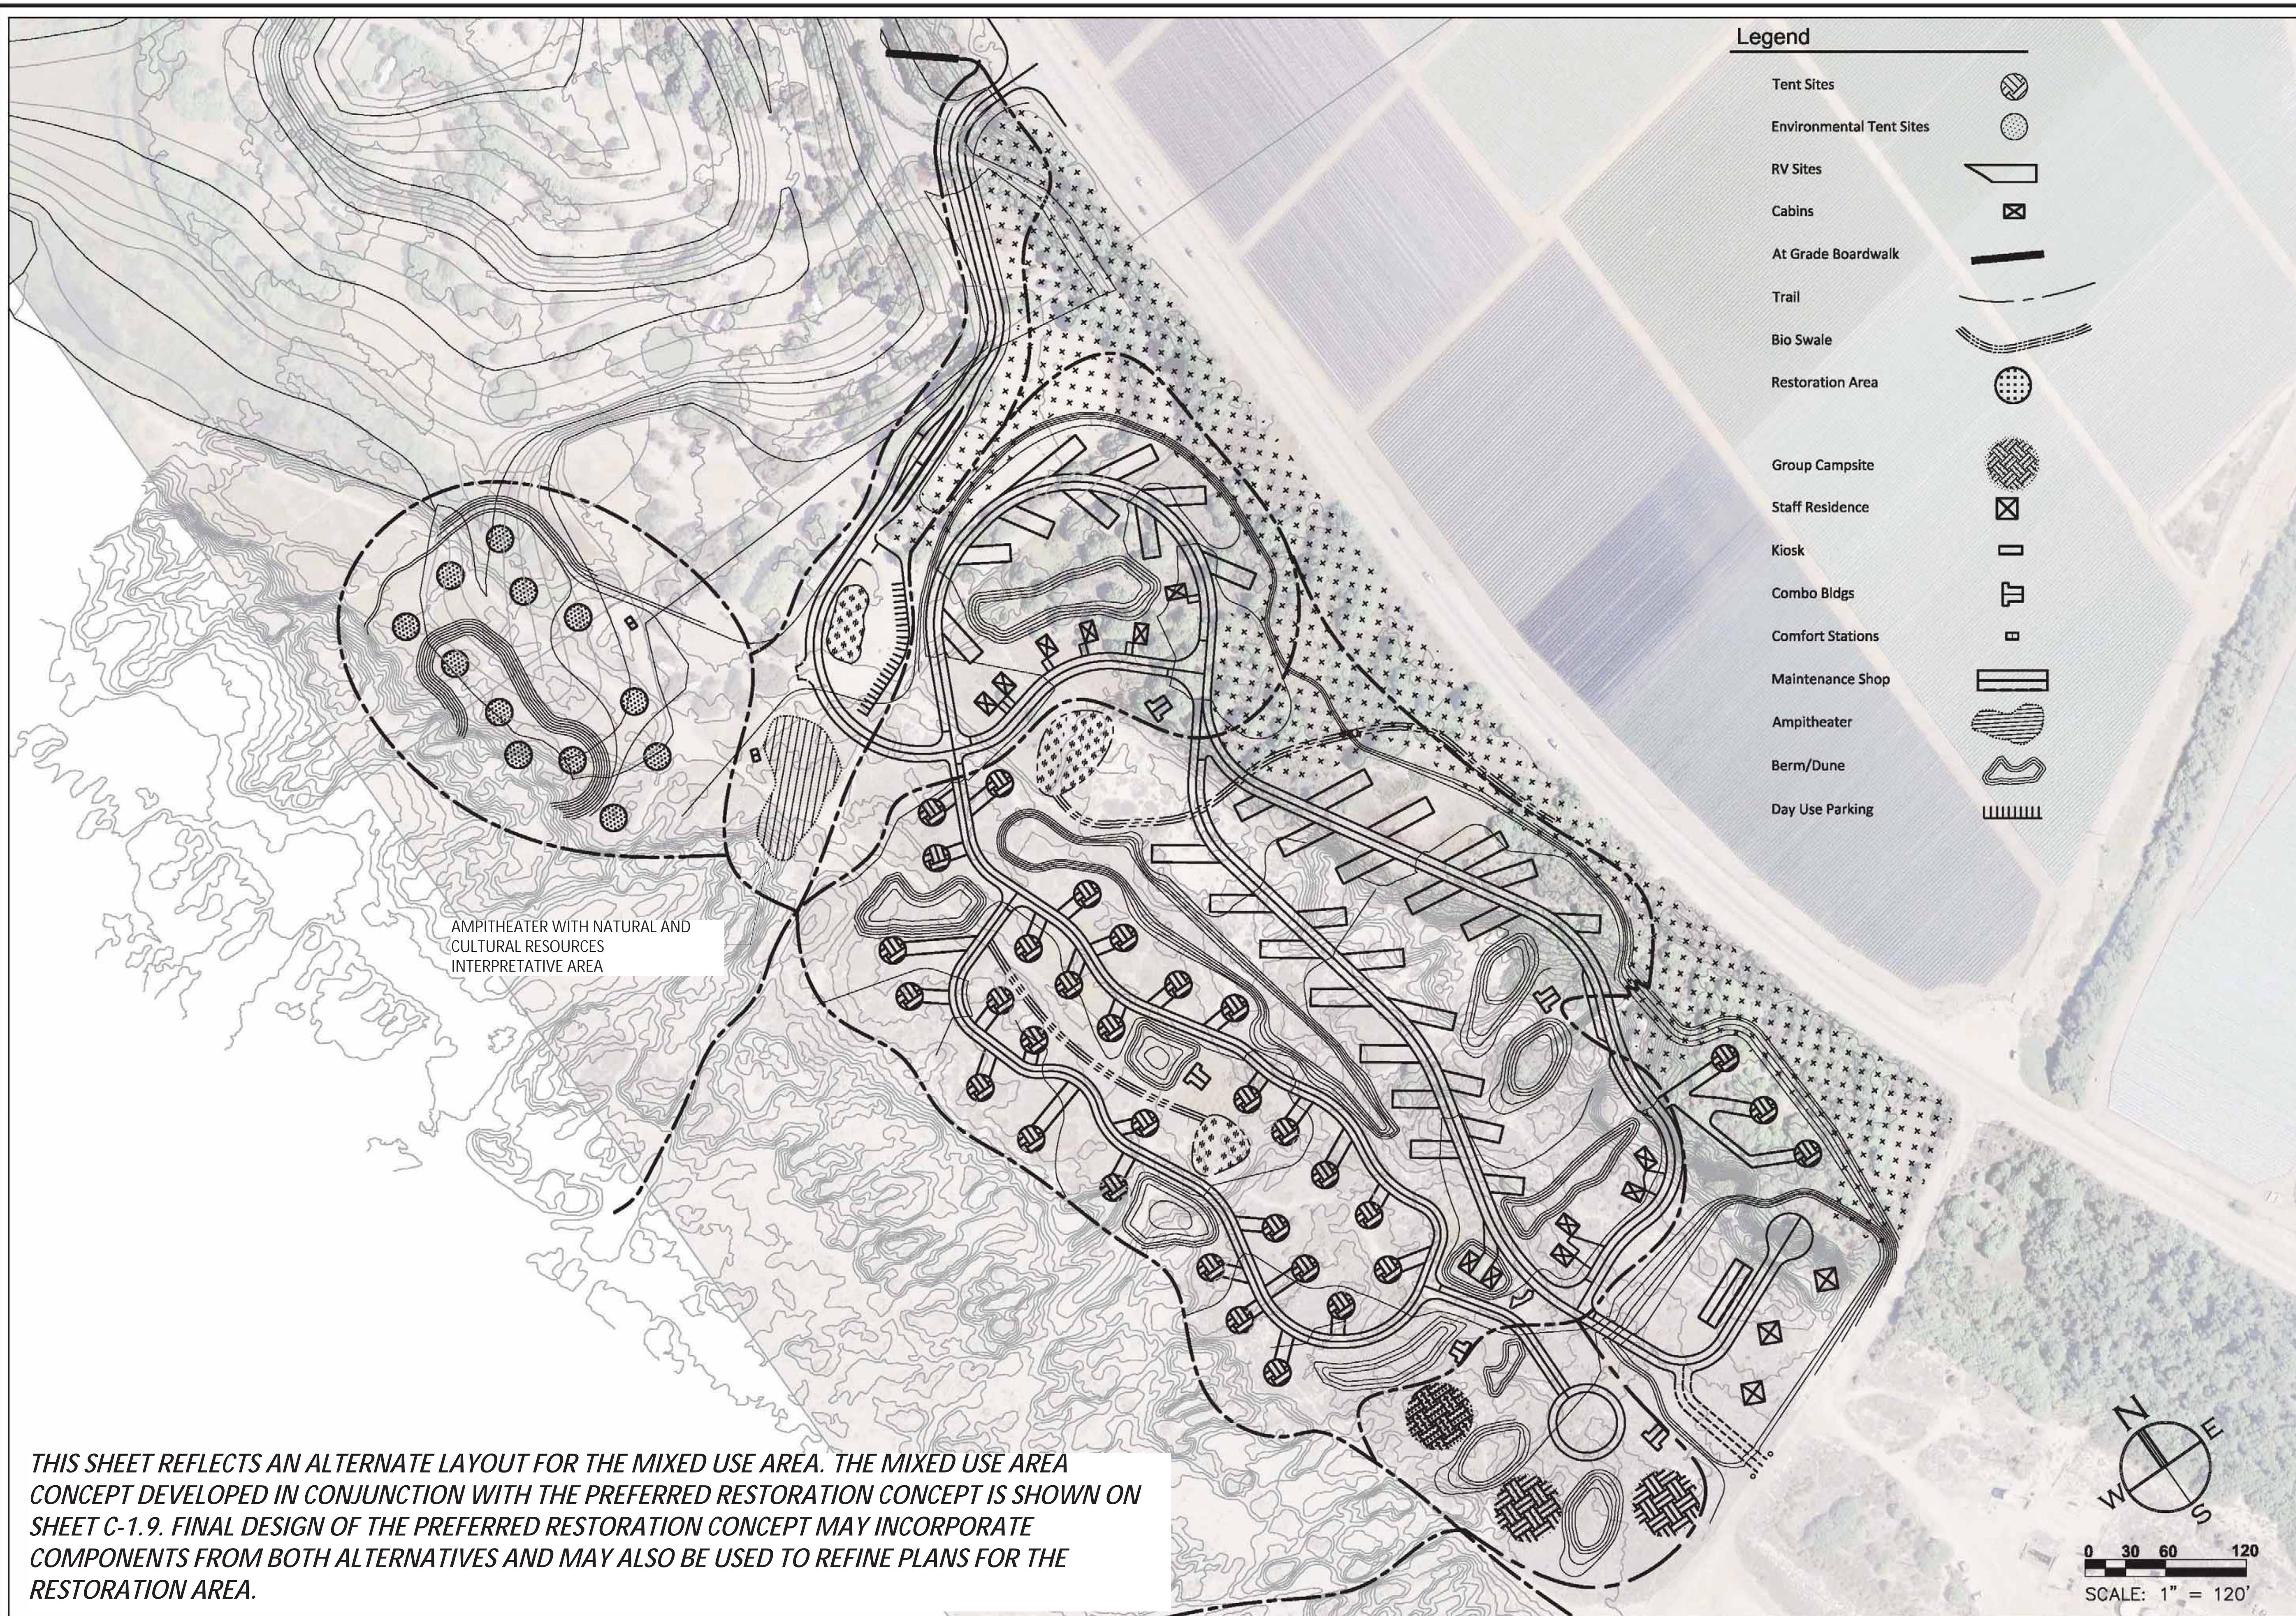
AMPITHEATER WITH NATURAL AND CULTURAL RESOURCES INTERPRETATIVE AREA

THIS SHEET REFLECTS AN ALTERNATE LAYOUT FOR THE MIXED USE AREA. THE MIXED USE AREA CONCEPT DEVELOPED IN CONJUNCTION WITH THE PREFERRED RESTORATION CONCEPT IS SHOWN ON SHEET C-1.9. FINAL DESIGN OF THE PREFERRED RESTORATION CONCEPT MAY INCORPORATE COMPONENTS FROM BOTH ALTERNATIVES AND MAY ALSO BE USED TO REFINE PLANS FOR THE RESTORATION AREA.

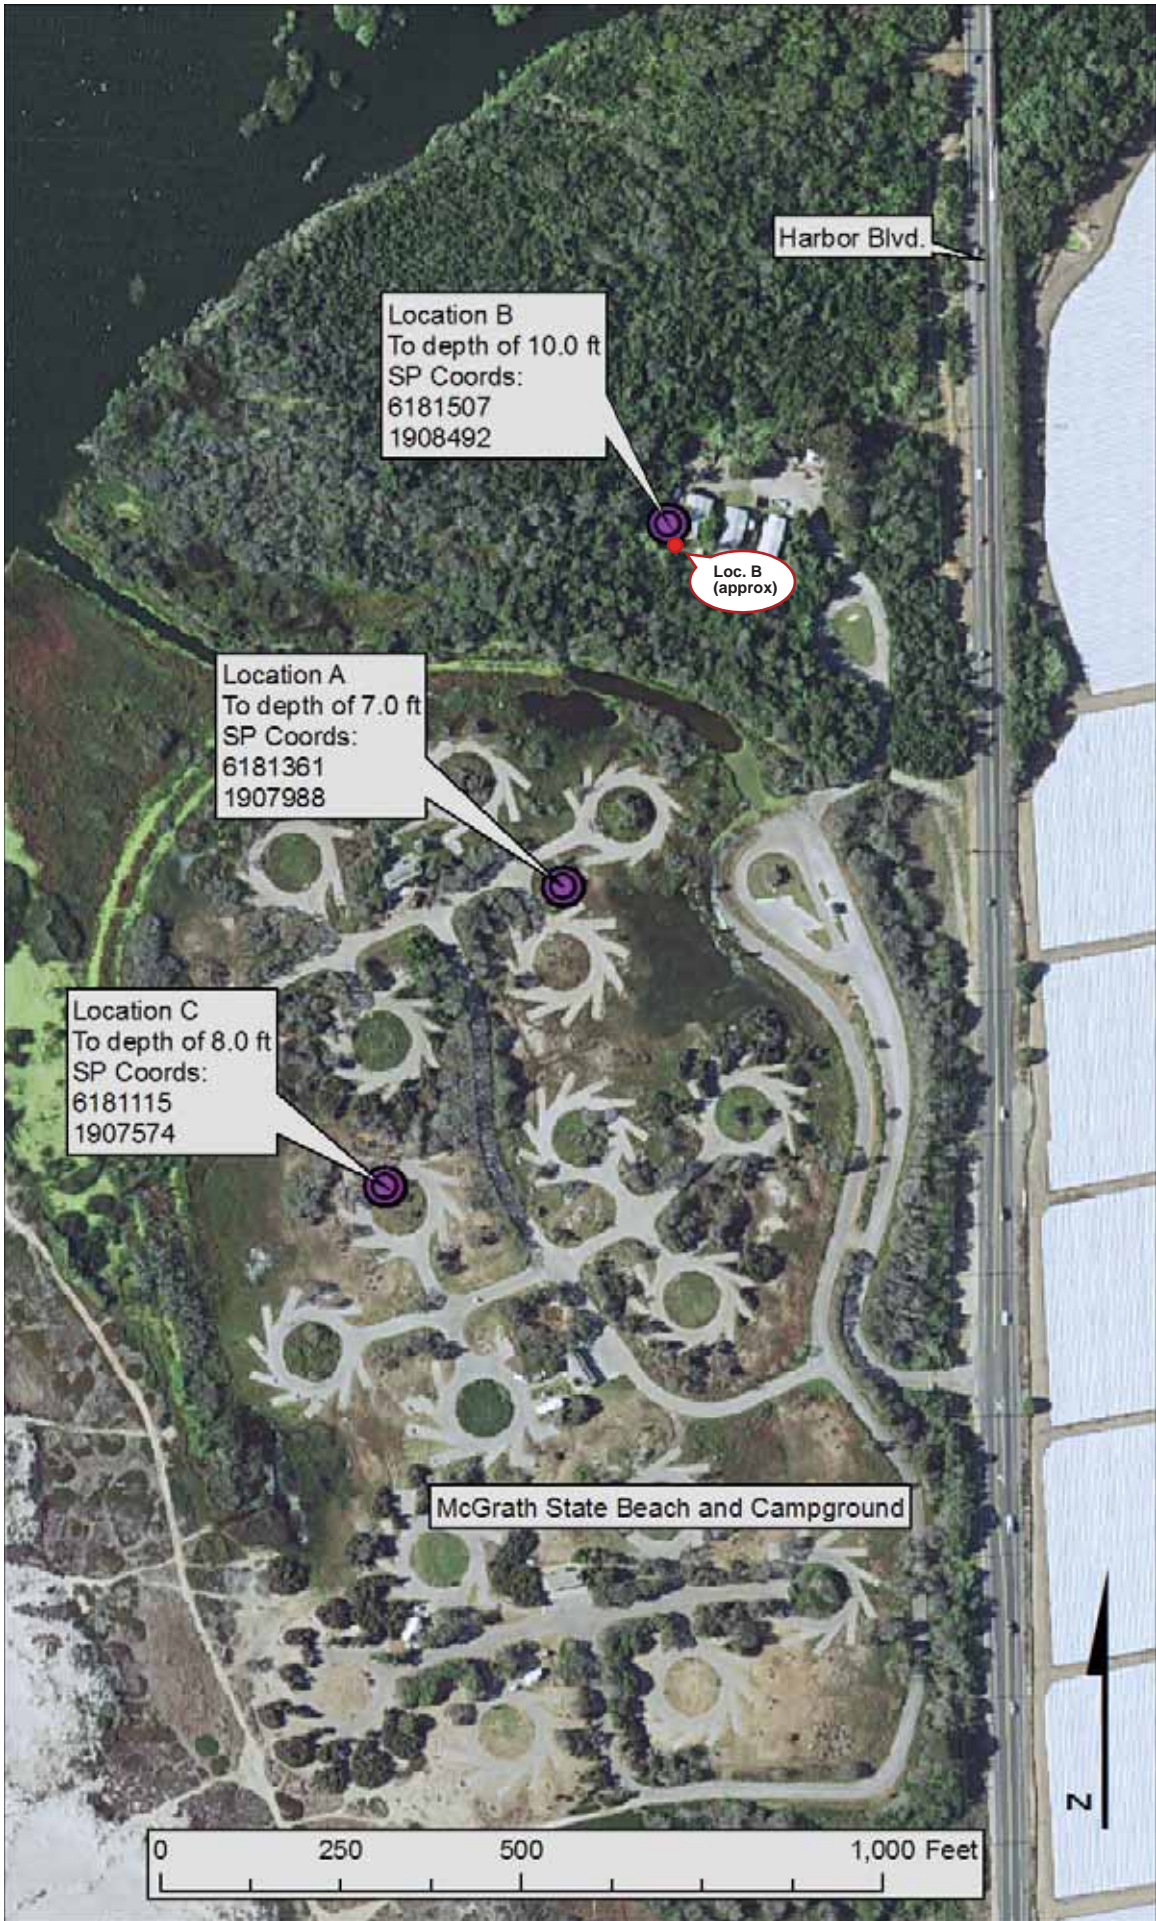
LOG OF HAND AUGER LOCATION A						
DEPTH (FEET)	ELEVATION (FEET)	MATERIAL SYMBOL	SAMPLE NUMBER	BLOW COUNT	LOCATION: See Location Map	TV or PP
					SURFACE ELEVATION: FEET (ref. MSL datum)	
					MATERIAL DESCRIPTION	
					ARTIFICIAL FILL(af)	
			A1		CLAY (CL) moderate brown, moist to wet, with fine sand and organics	
			S1 (bulk)	(1.5)	Sandy SILT (ML)/Silty fine SAND (SM): moderate yellowish brown, moist, with clay, slightly micaceous	
2					ALLUVIUM (Qal)	
					Sandy SILT (ML): moderate yellowish brown mottled with light gray and orangish brown, moist, slightly micaceous	
			A2	(3.3)	Silty fine SAND (SM): moderate gray, mottled with orangish brown, wet, slightly micaceous, with scattered organics	
4					- dark gray with minor orangish mottling, below 4.2'

Attachments: Exploration Location Plan by CBEC, Inc.
Plates A-1 through A-3 – Log of Drill Holes
Plates B-1 through B-3 – Grainsize Curves
Plates B-4 through B-6 – Compaction Curves

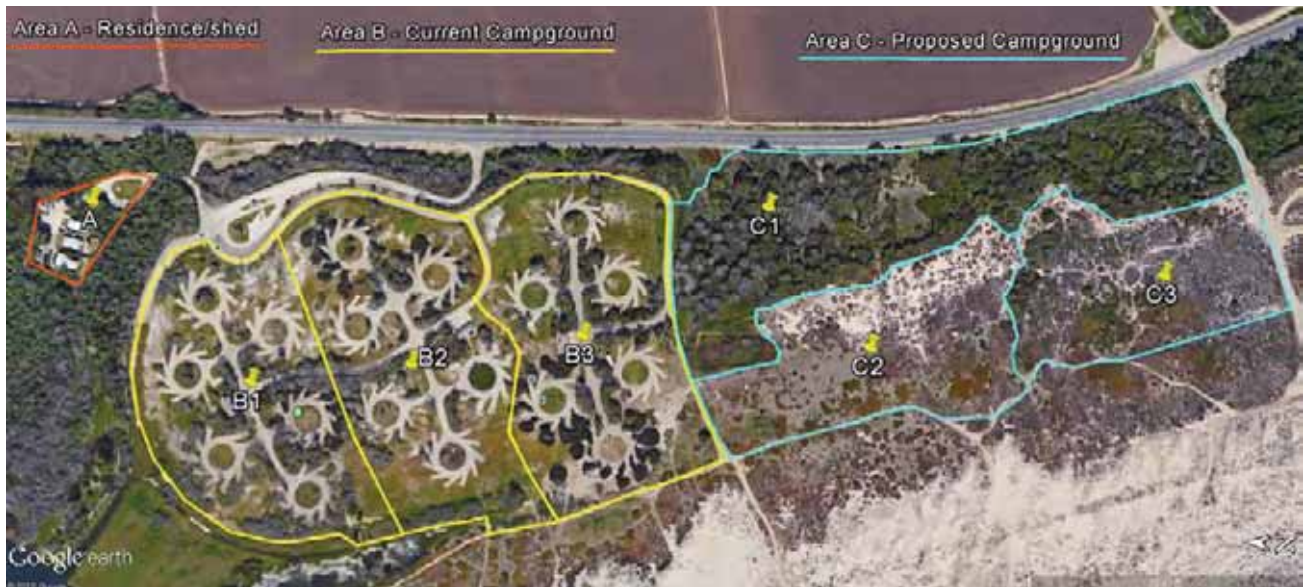
Figure 2. Project area map used by Canine Forensics team. Search area C1 lies between the leeward side of the dunes separating it from areas C2 and C3 and Harbor Boulevard. Area C1 is heavily wooded. Search areas C2 and C3 are between the sand dunes along the coast and the second band of dunes and are covered with iceplant and other low growing vegetation. The cultural resource, archaeological and paleontological surface survey covered the same areas.

The State Beach contains many plants native to the wetlands and sand dunes. There are several different types of vegetation and habitat. The project area includes relatively distinct differences in vegetation cover indicated in Figure 2. The existing campground contains roadways,

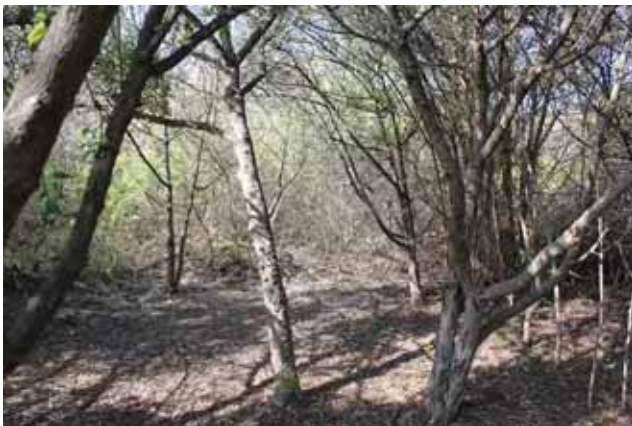
Figure 3. Wooded area west of Harbor Boulevard and east of sand dunes.

The area of the proposed campground is inland from the sand dunes adjacent to the beach and is separated by a row of sand dunes. The area between these dunes and Harbor Boulevard is heavily wooded with *Myoporum laetum* and willow trees and poison oak vines (Figures 3 and 4). Trails and the remains of camps have created areas of open ground in this area. The dunes to the west (Figure 5) and the area west of the dunes (Figures 6 and 7) contain mostly low growing vegetation. In both areas, vegetation covered much of the ground surface.

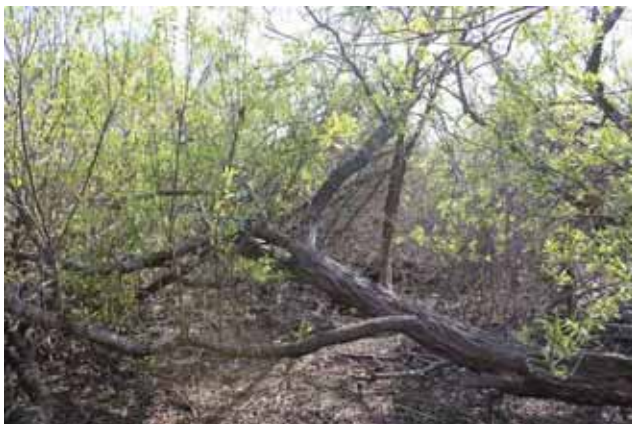
Figure 4. Wooded area west of Harbor Boulevard and east of sand dunes.

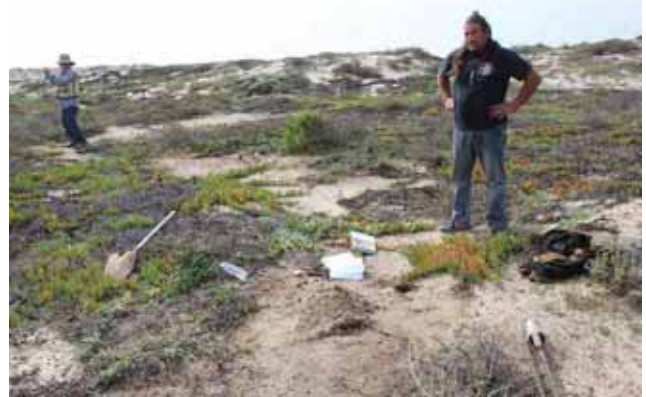
Figure 5. Sandy terrace at auger boring site.

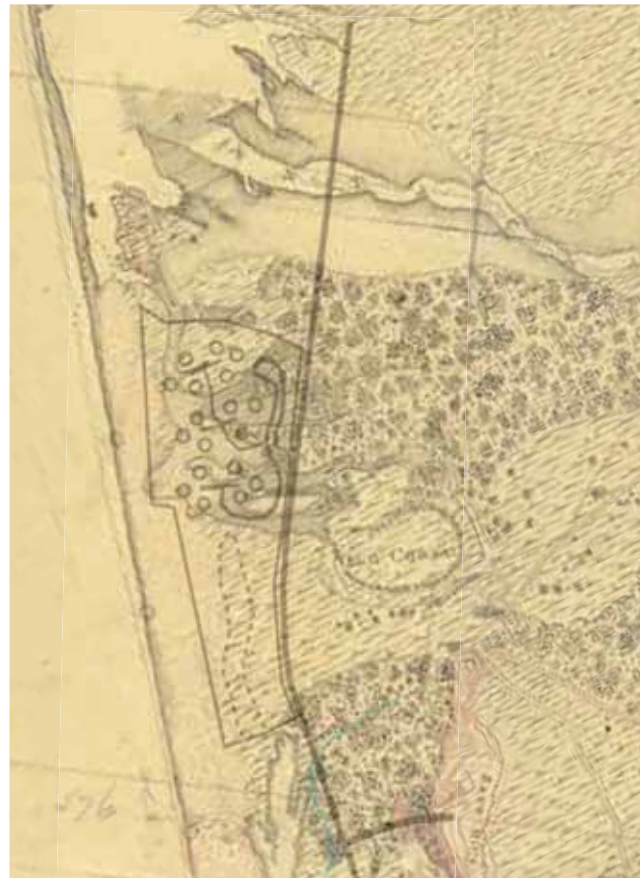
Figure 10. Project area superimposed over 1855 Coast and Geodetic Survey Map. Note scour channels in the area of the existing campground.

Eastern portions of the project area are located on the Seacliff Terrace. A widespread buried surface at 4 feet depth (about 9 feet elevation) occurs in this terrace. Its age is uncertain but likely in the range of 2,000-5,000 years old. Upper portions of the Seacliff Terrace consist of more recent river quietwater floodplain deposits (after a large flood recedes, the terrace is covered by a layer of silty clay mud; over time and subsequent floods the terrace surface aggrades vertically). The buried surface also occurs beneath twentieth century alluvium in the area of the existing campground. There the buried surface may be scoured by high energy scour channels and filled during nineteenth and twentieth century floods. Figure 10 indicates the presence of old scour channels in the campground area in 1855.

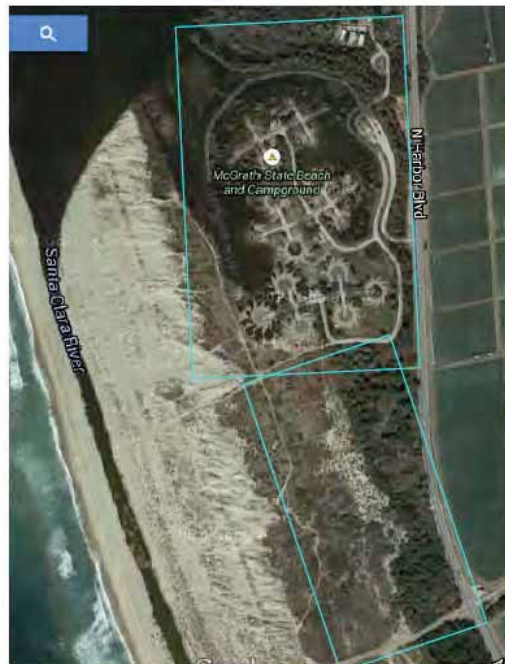
Fig. 1: McGrath Campground Project Area, the upper blue box is the project boundary for the Santa Clara River Estuary Steelhead Habitat Restoration and Enhancement Plan (existing campground area), and the lower blue box is the project boundary for the McGrath State Beach Campground Relocation (new campground area).

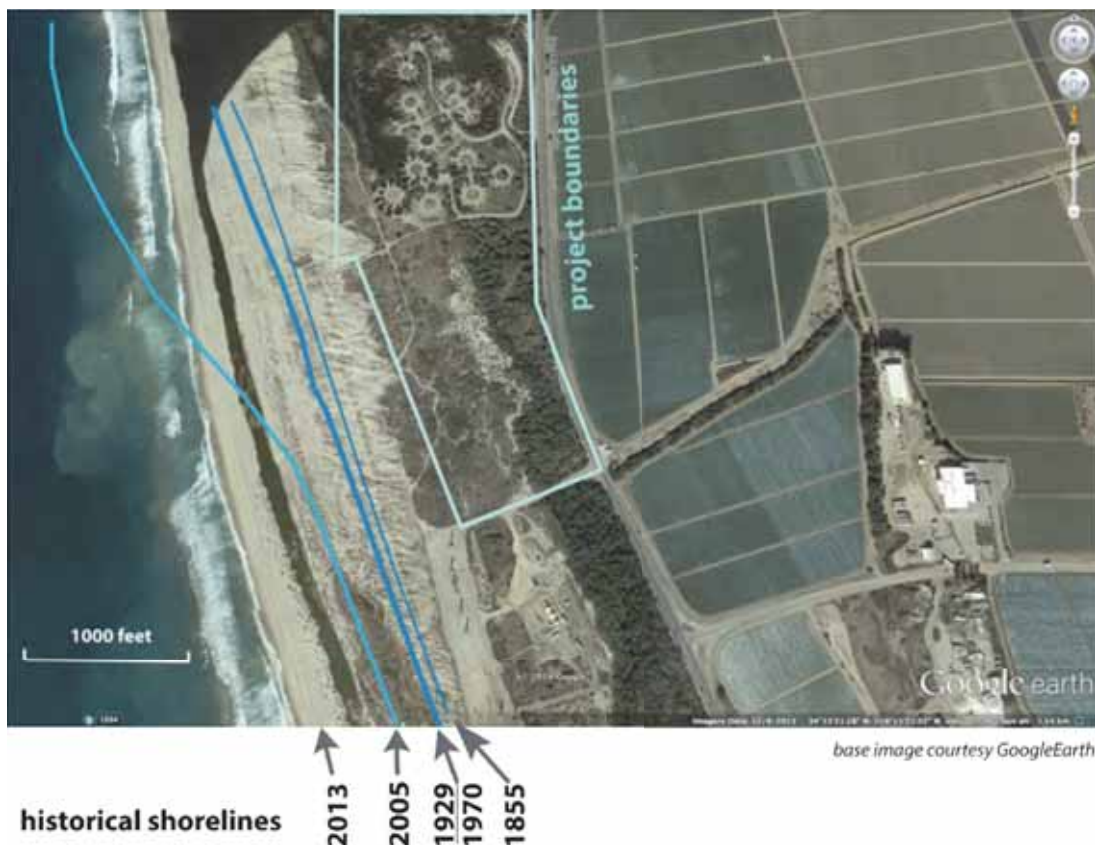
Fig. 2: Location of Historical Shorelines at McGrath Beach (1929 and 1970 shorelines about the same; 1855 shoreline estimated)

At McGrath Beach (Fig. 2), aerial photographs from 1927 and 1929 indicate the shore is similar to the mapped 1933 shoreline. Pierpont Bay contains a distinctive line, or curve, in early twentieth century aerial photographs (1927, 1929) in front of the first belt of dunes and dune vegetation approximating the location and shape of the mapped 1855 shoreline. This beach line can be followed downcoast beneath dunes as far as Arundell Barranca, and again at McGrath where it is buried by dunes behind the 1927-9 beach. The shoreline continues to move oceanward, being over a hundred feet wider in the 1945-47 aerial photographs. However, beach erosion associated with dam construction on the Ventura River and a dry climatic period pushed the beach at McGrath back by 1970 to its approximate position in 1929. Although the 1969 flood created a new bulging shoreline in front of the lagoon, the beach in front of McGrath doesn't begin aggrading until the later seventies as longshore drift begins to move sand in front of the lagoon downcoast. Since then the shoreline has continue to aggrade, and has moved oceanward about 500 feet during 1970-2005 (35 year period). A similar sediment pulse occurred after the 2005 flood when the river mouth, jetting out from the levees, eroded its bank and pushed the

All historical shorelines are located west of the project area in the modern beach zone, and the project area was not directly threatened by twentieth century beach erosion or changes.

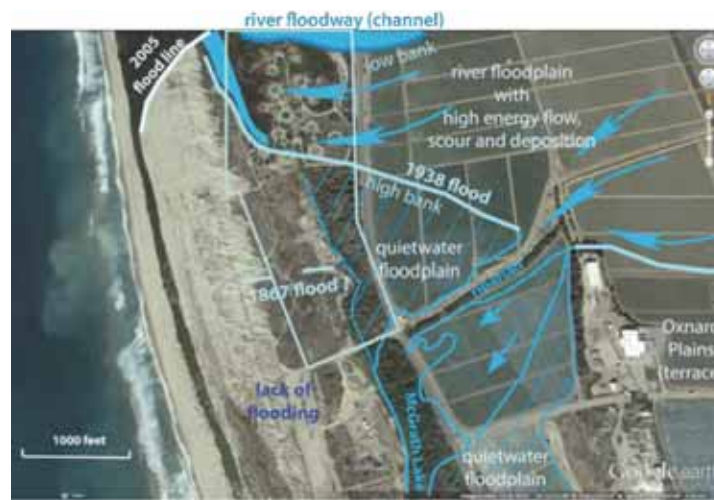
Within the project area (Fig. 4), the twentieth century floodway bank forms the northern boundary of the existing campground. North of this bank (blue area in Fig. 4) the riverbed has been greatly scoured and its streambed represents sediment in transition. Also shown is the 1938 flood line bordering areas affected by channel overbank flows strong enough to create scour channels, deposit sediment, and create visual scrolls on early aerial photographs, and weaker flows in quietwater flooding areas lacking scour and having thin silty clayey mud deposits (eastern portion of campground relocation area).

Fig. 4: Details of Early Twentieth Century River Floodplain and Inundation

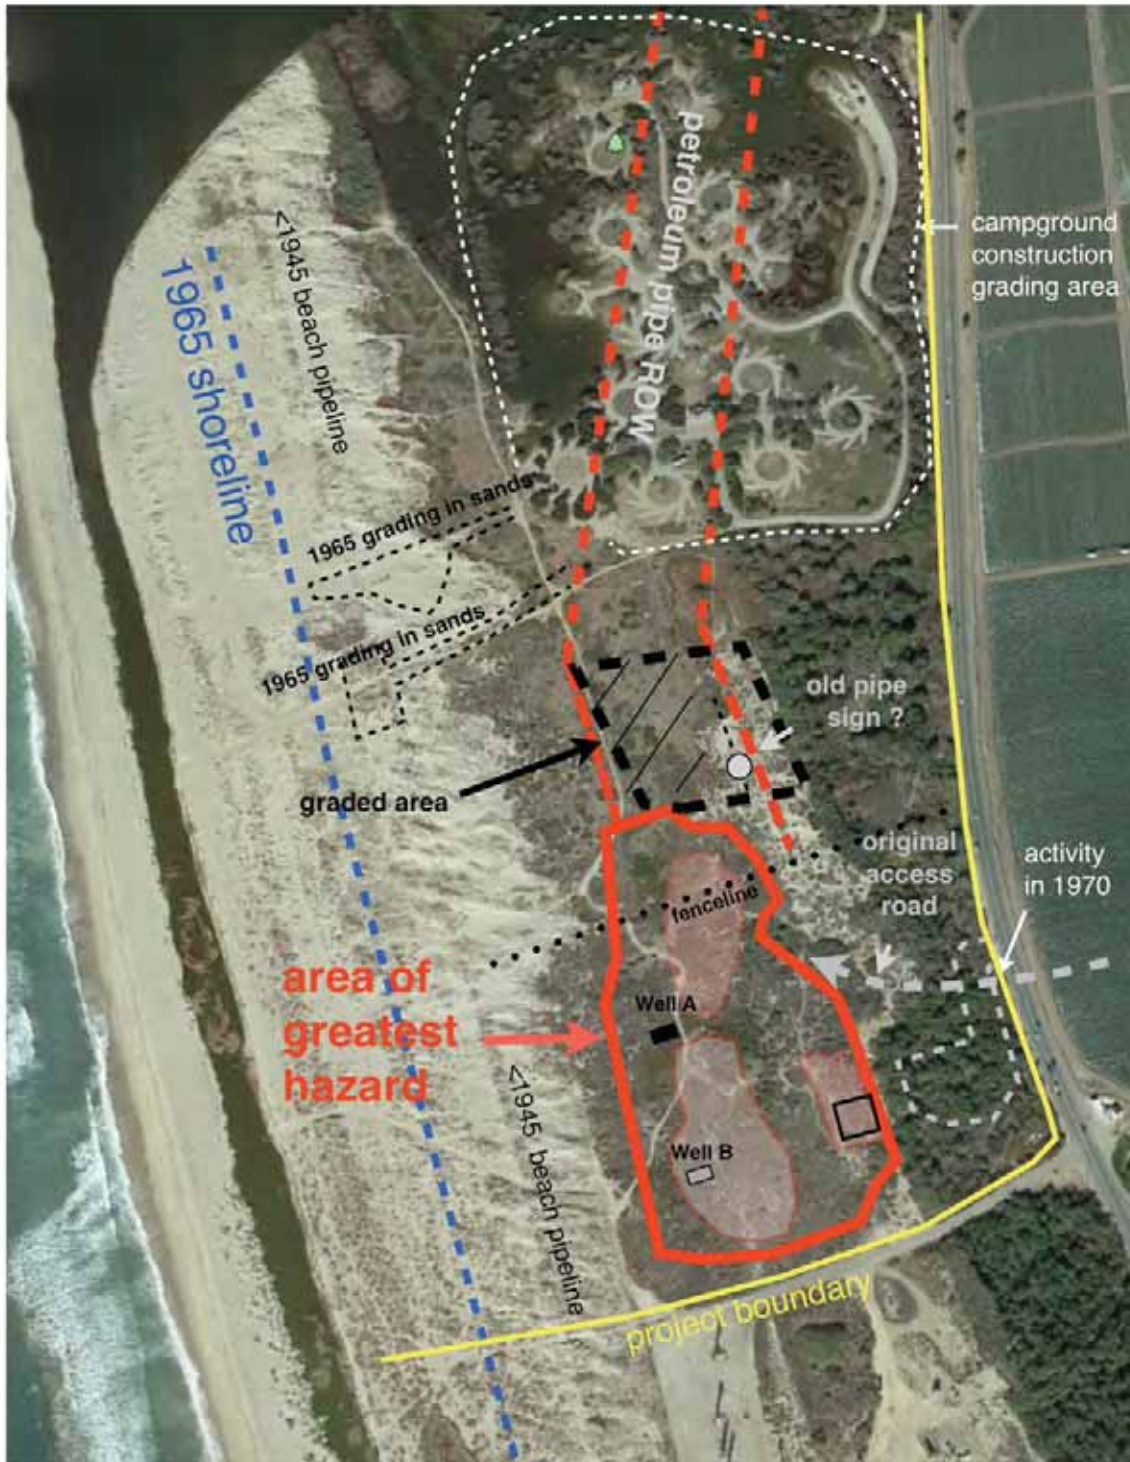
Fig. A1: Map of Potentially Hazardous Areas of Former Oil Field and Suspected Affected Areas (areas in red)

A note on potential hazards. Activities associated with development of the West Montalvo Oil Field occurred in the study area between about 1950 and 1972. During that period two wells were drilled and operated for a short time, a buried pipeline to (presumably) refineries to the north constructed, along with access roads, graded areas, construction and demolition of embankments/dikes, and possible sumps. At this time the process of abandonment and any remediation work for these mid-twentieth century facilities is uncertain. Thus, until it can be proven otherwise, a “worst-case scenario” is assumed for this project that implies the possibility of encountering *in certain areas* affected soils during subsurface exposure (augering, shovel pits, or trenching). These hazards might not exist (due to good remediation), might involve slightly affected soils (those possibly containing trace amounts of affected material yet below regulatory concern), to strongly affected soils (those containing remnants of subsurface sumps or plumes from leaks in, or spills from pipes, valves and equipment, or from oil field operations involving cleaning out pipes). A hazard map was assembled using this information. One option is to avoid these areas during subsurface work (hand augering).

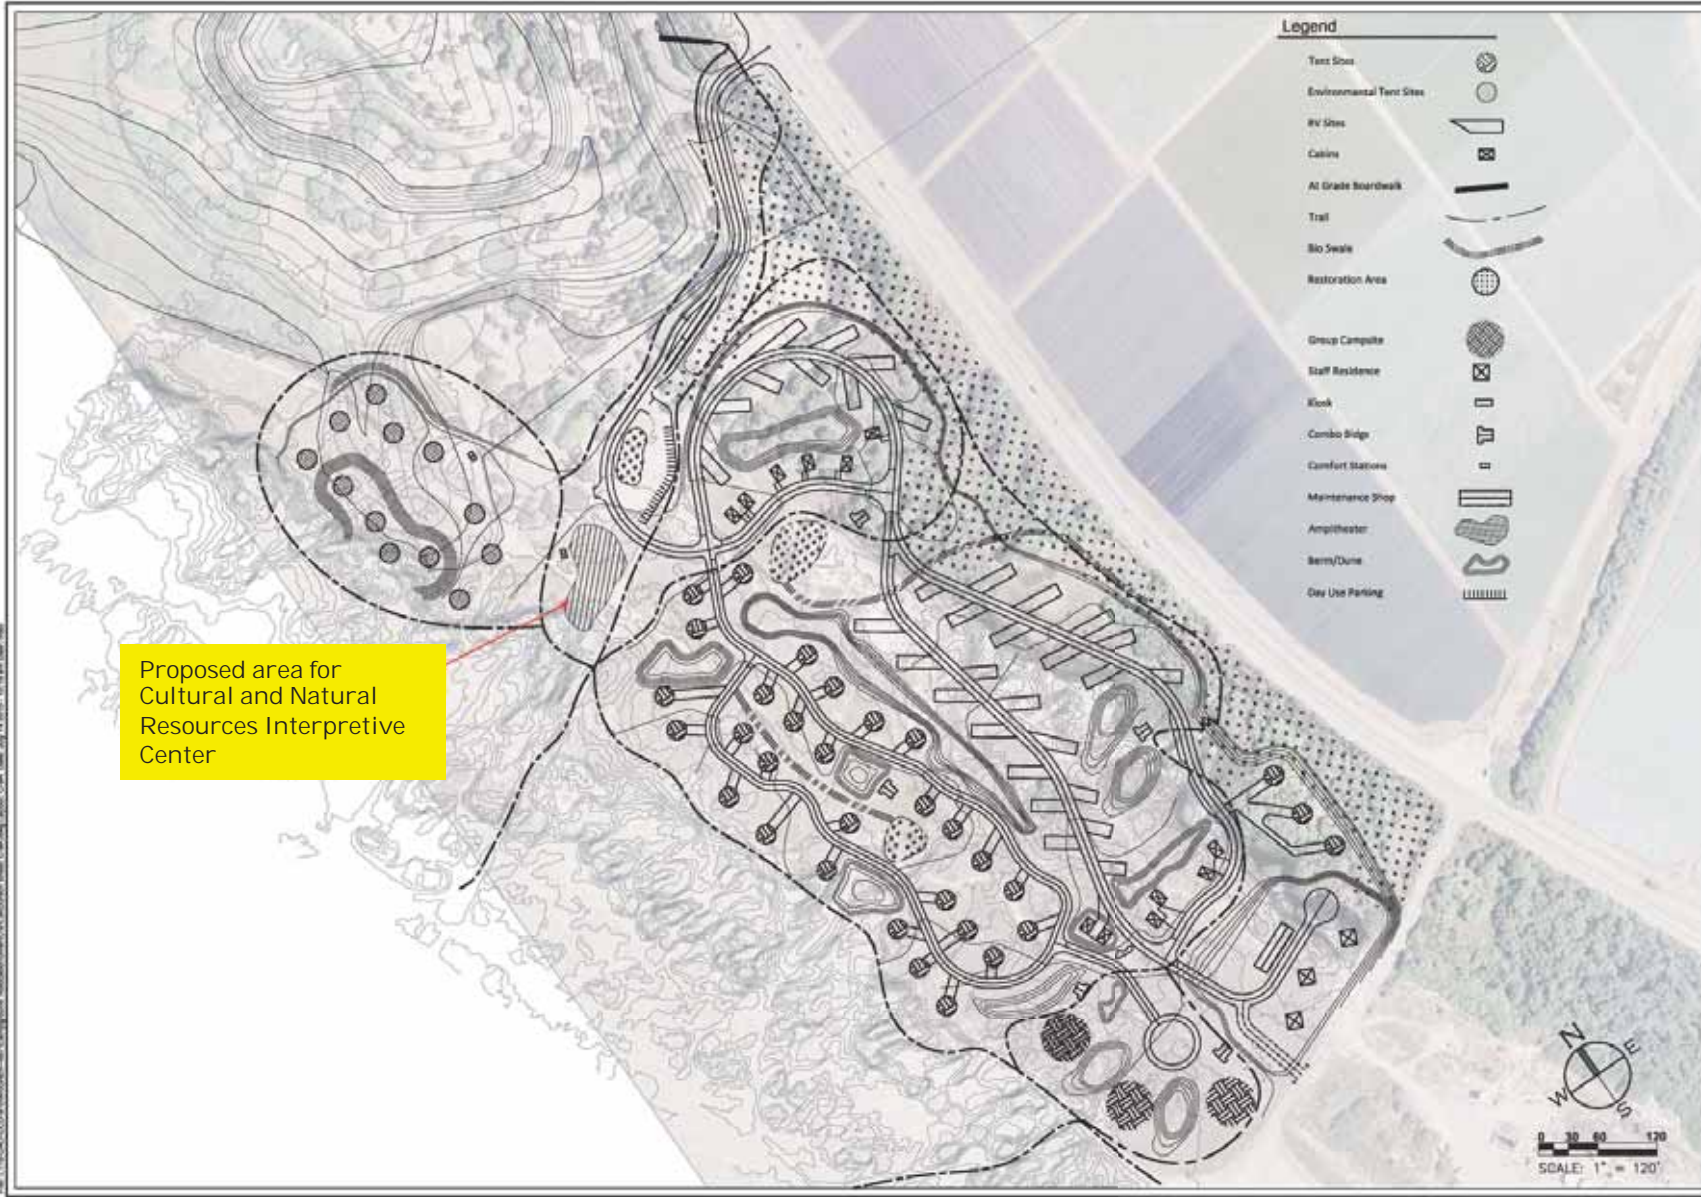
SHEET NO.
C-1.9Alt
10 of 22

MCGRATH STATE BEACH
SANTA CLARA RIVER ESTUARY HABITAT RESTORATION
AND ENHANCEMENT FEASIBILITY STUDY
CAMPGROUND SITE PLAN

Proposed area for Cultural and Natural Resources Interpretive Center

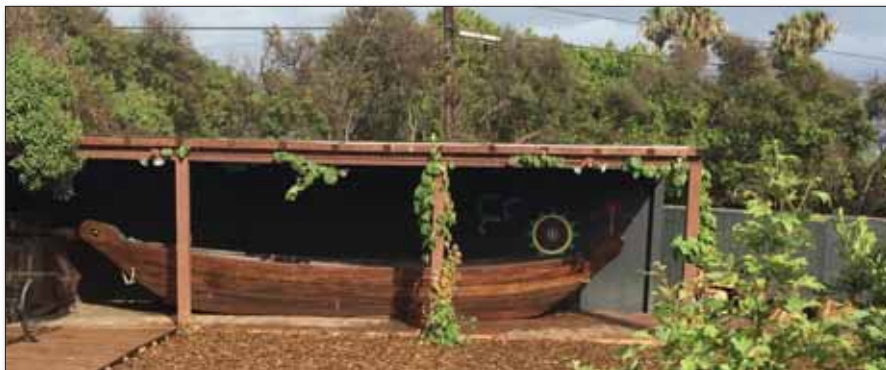
Redwood Plank *Tomol* (Chumash canoe/Ocean vessel) and *Tomol* House

- 26 Ft. Redwood Plank *Tomol* – Estimate: \$35,000 (includes time and materials)

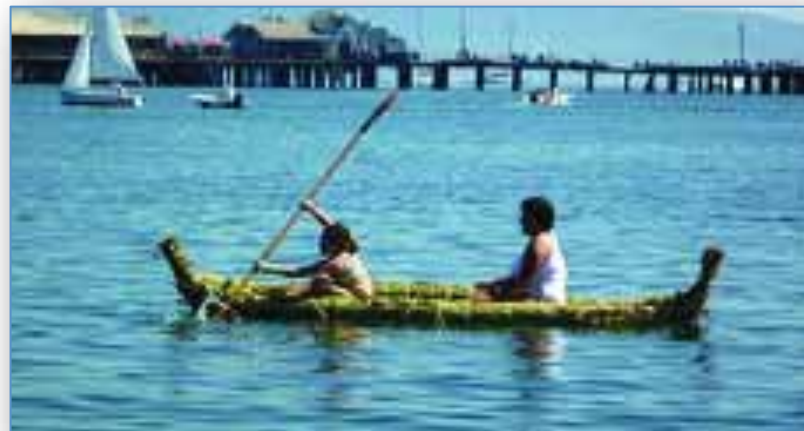
Tule Reed Boat (river vessel)

- 12 - 15 ft. Tule Reed Boat – Estimate: \$5,000 - \$7,000 (includes time and materials)

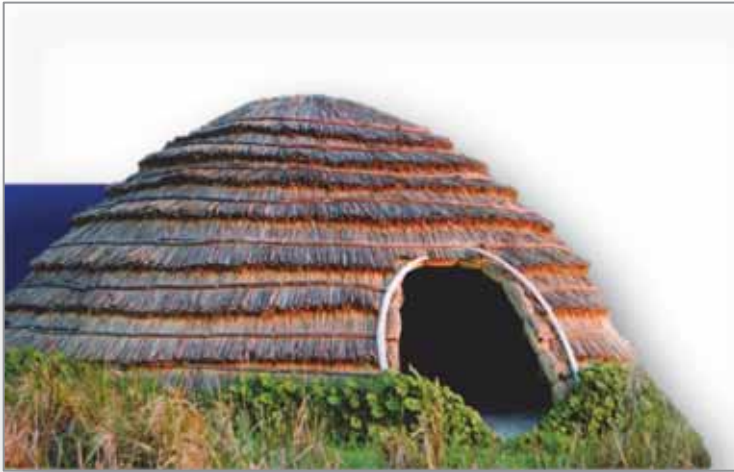
Chumash House called 'ap made with a willow frame and tule thatching. More than one house called 'ap 'ap.

- 1 'ap – 9 ft. X 20 ft. – Estimate: \$24,000 (includes time & materials and takes approximately 4 months to build and will hold 25 - 30 people.)
- 1 'ap – 7 ft. x 14 ft. – Estimate: \$18,000 (includes time & materials and takes approximately 3 months to build.)

A traditional Chumash domed home – called an 'ap – is made from štayit (willow) and swa' (tule). This 'ap is one of 8 which exist at the Wishtoyo Chumash Village in Malibu, and is used for ceremonial, educational and community purposes.

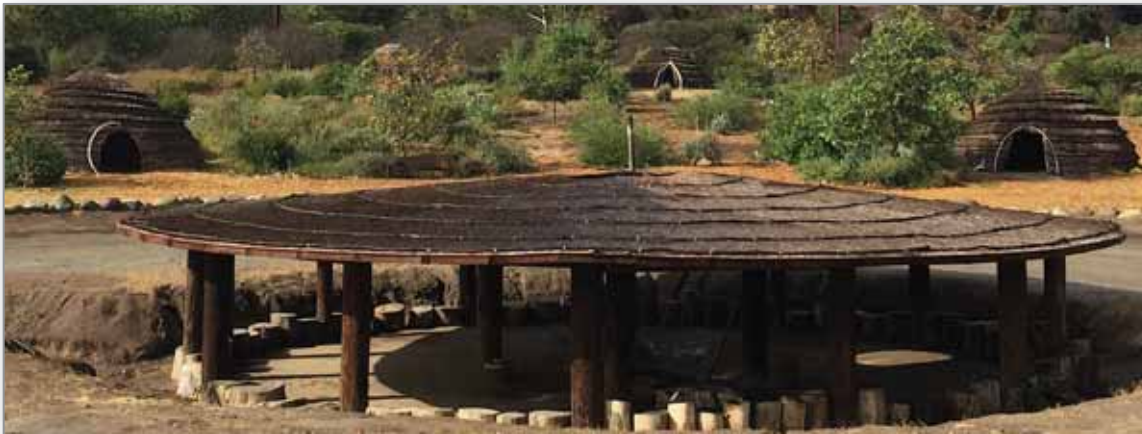
Sil'i'yik - Chumash Ceremonial and Gathering Area/Amphitheater with Fire Circle

- *Sil'i'yik* 40 ft. Round and 11 Ft. in Center and 10.6 Ft. high on periphery.
- Estimate: \$45,000 (includes time and all materials. Takes approximately two months to build and will hold 100+ people.
